TECHNICAL REPORT GL-86-7

SEISMIC STABILITY EVALUATION OF ALBEN BARKLEY LOCK AND DAM PROJECT

Volume 5 STABILITY EVALUATION OF GEOTECHNICAL STRUCTURES

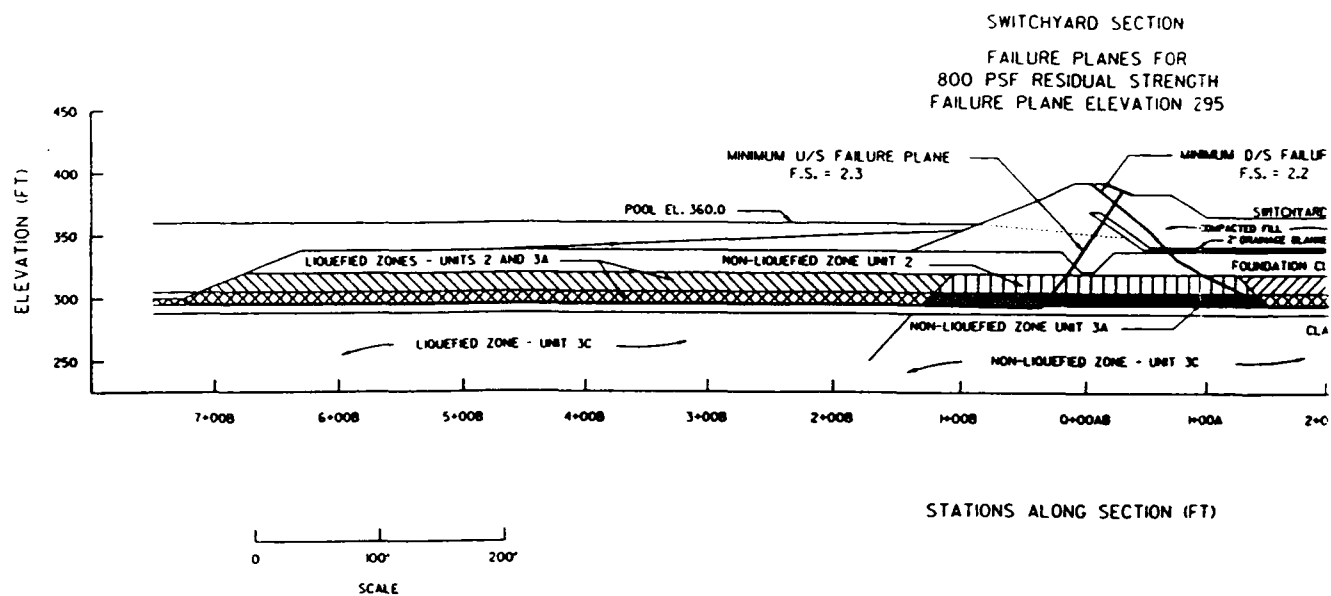
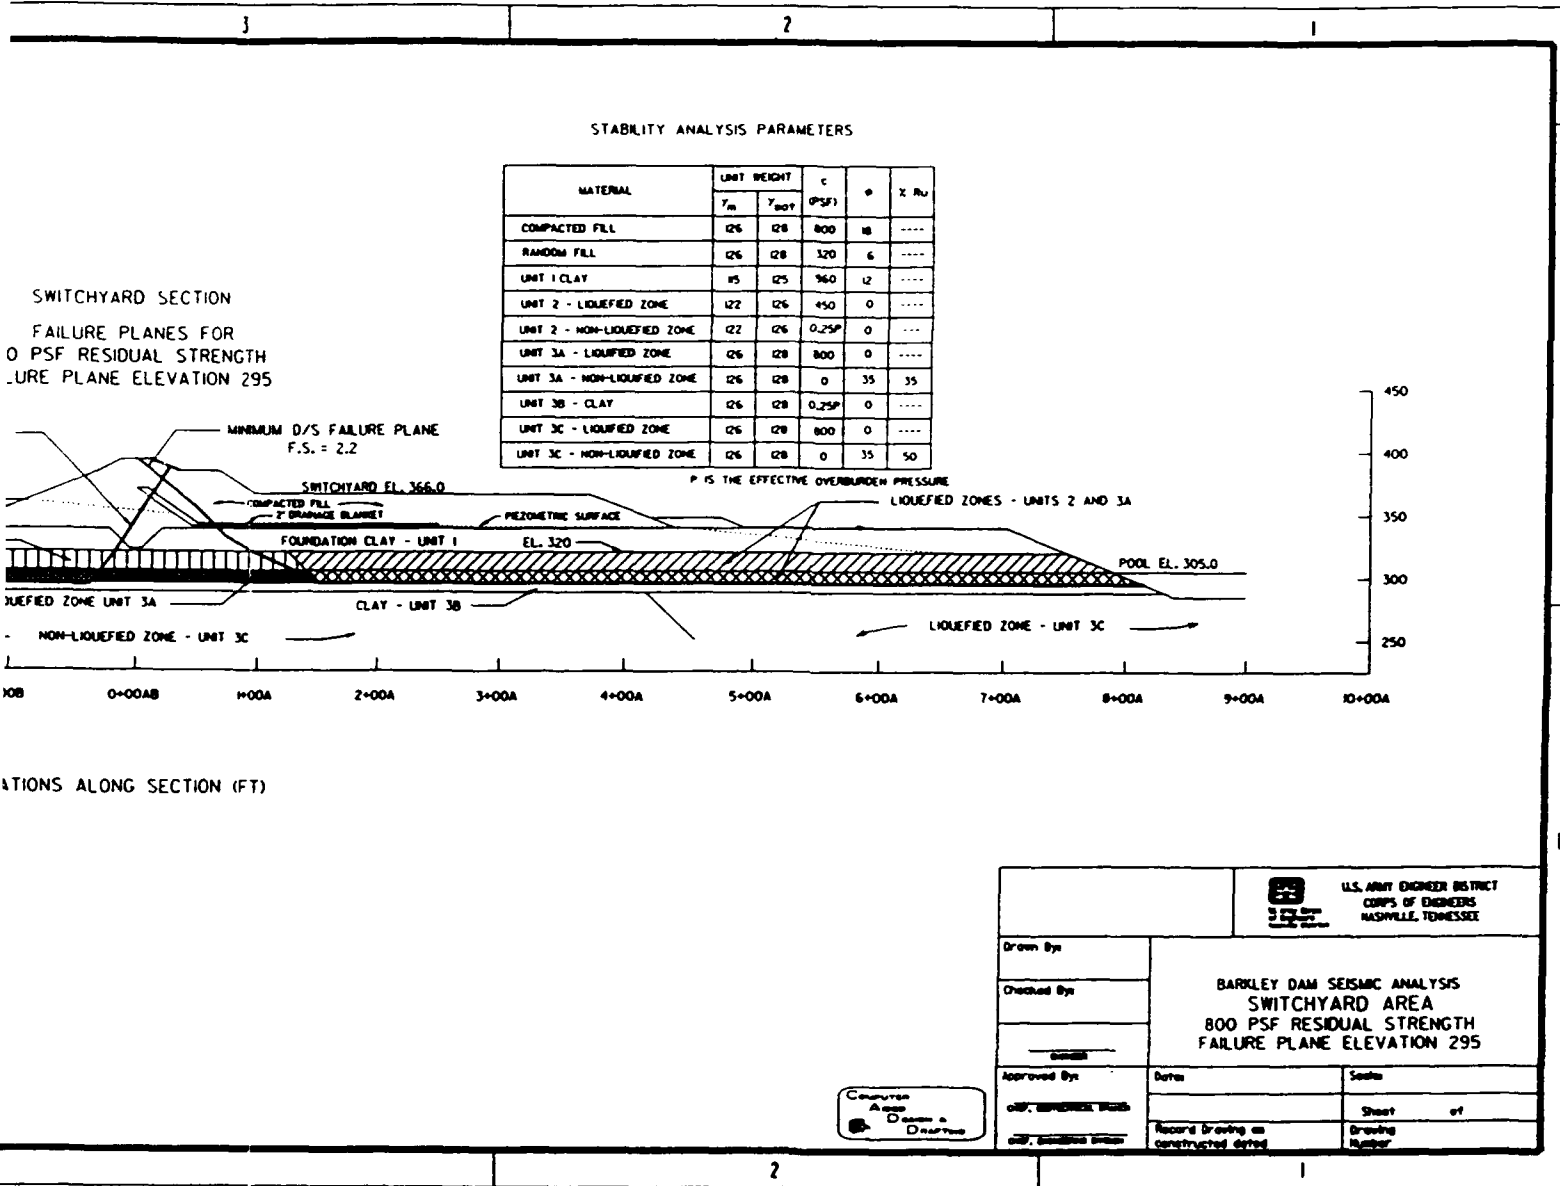
Figure 20. Minimum failure planes at 800 psf residual strength in lique

um failure planes at elevation 295 feet with
ial strength in liquefied zone of Unit 3A.

44. Using the full residual strength of 1200 psf, the minimum failure surface at elevation 295 feet produced factors of safety of 3.8 and 2.6 for the upstream and downstream slopes, respectively, indicating that large scale movement and deformations are not anticipated. Using zero strengths in the liquefied zones produced factors of safety of 0.5 and 0.6 for the respective failure surfaces. For the minimum upstream and downstream failure planes, a residual strength of 200 and 250 psf, respectively, is needed for a stable condition. The pre-earthquake safety factors for the upstream and downstream surfaces are 4.4 and 7.2, respectively. The minimum failure surfaces are shown in Figures 20 and 21 and Table 2 summarizes the results.

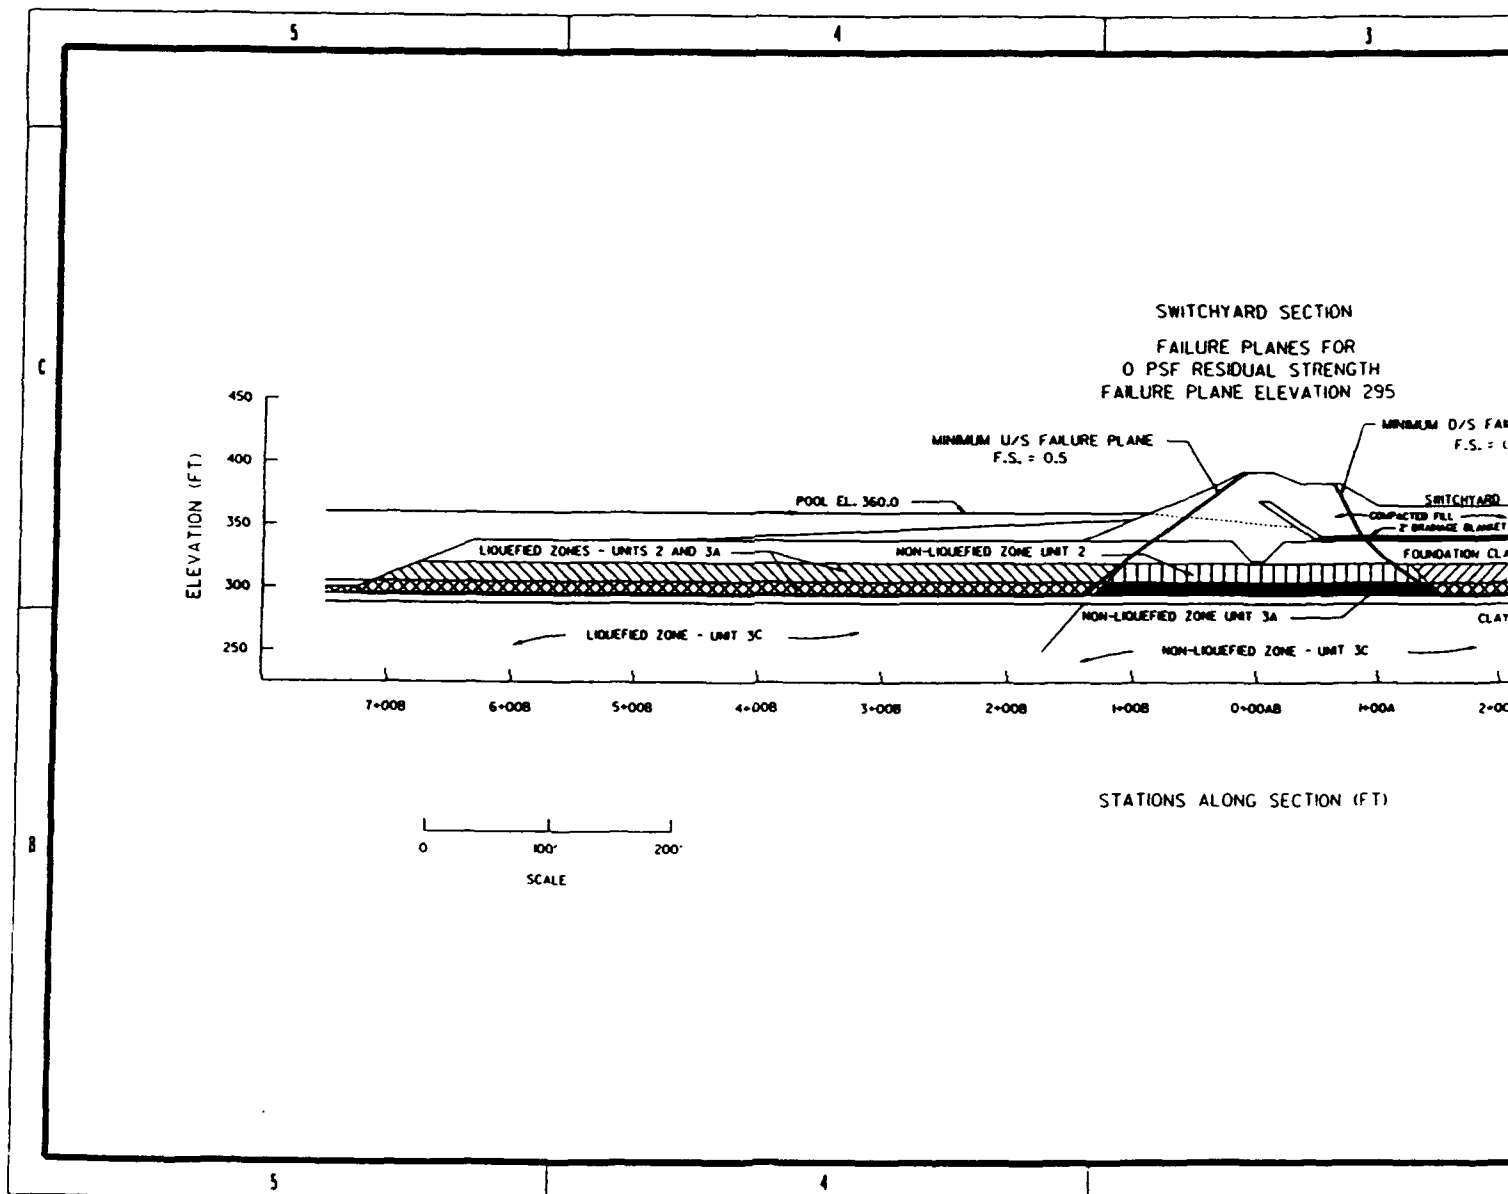
Figure 21. Minimum failure planes at 0 psf residual strength in

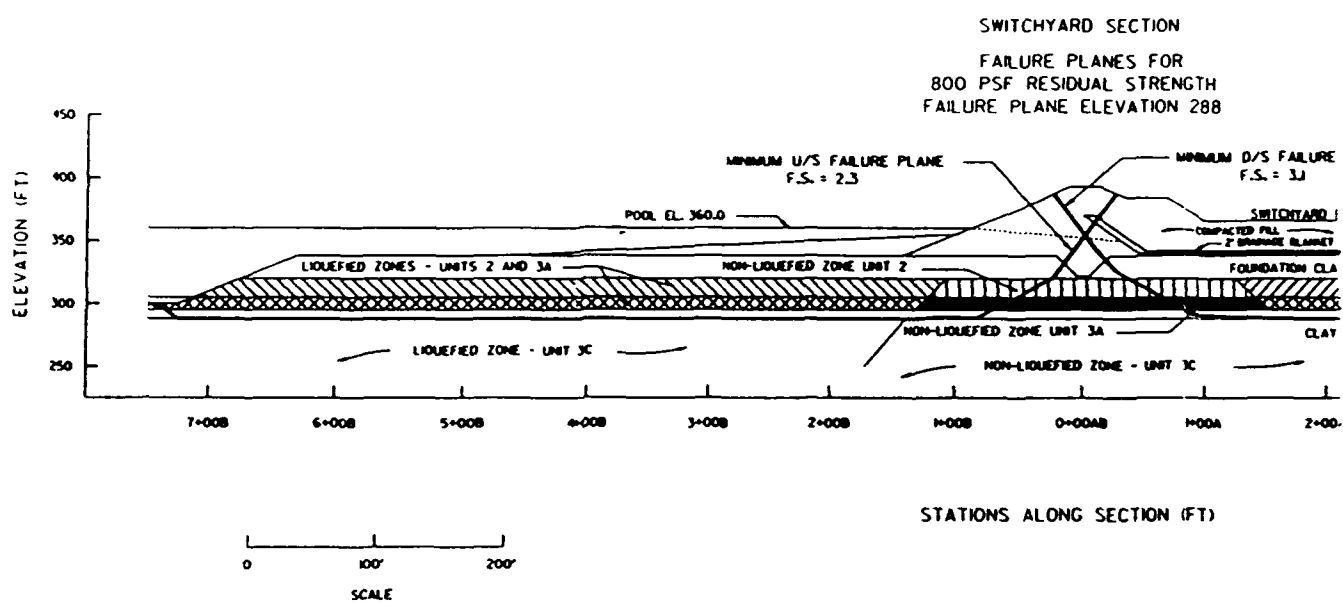
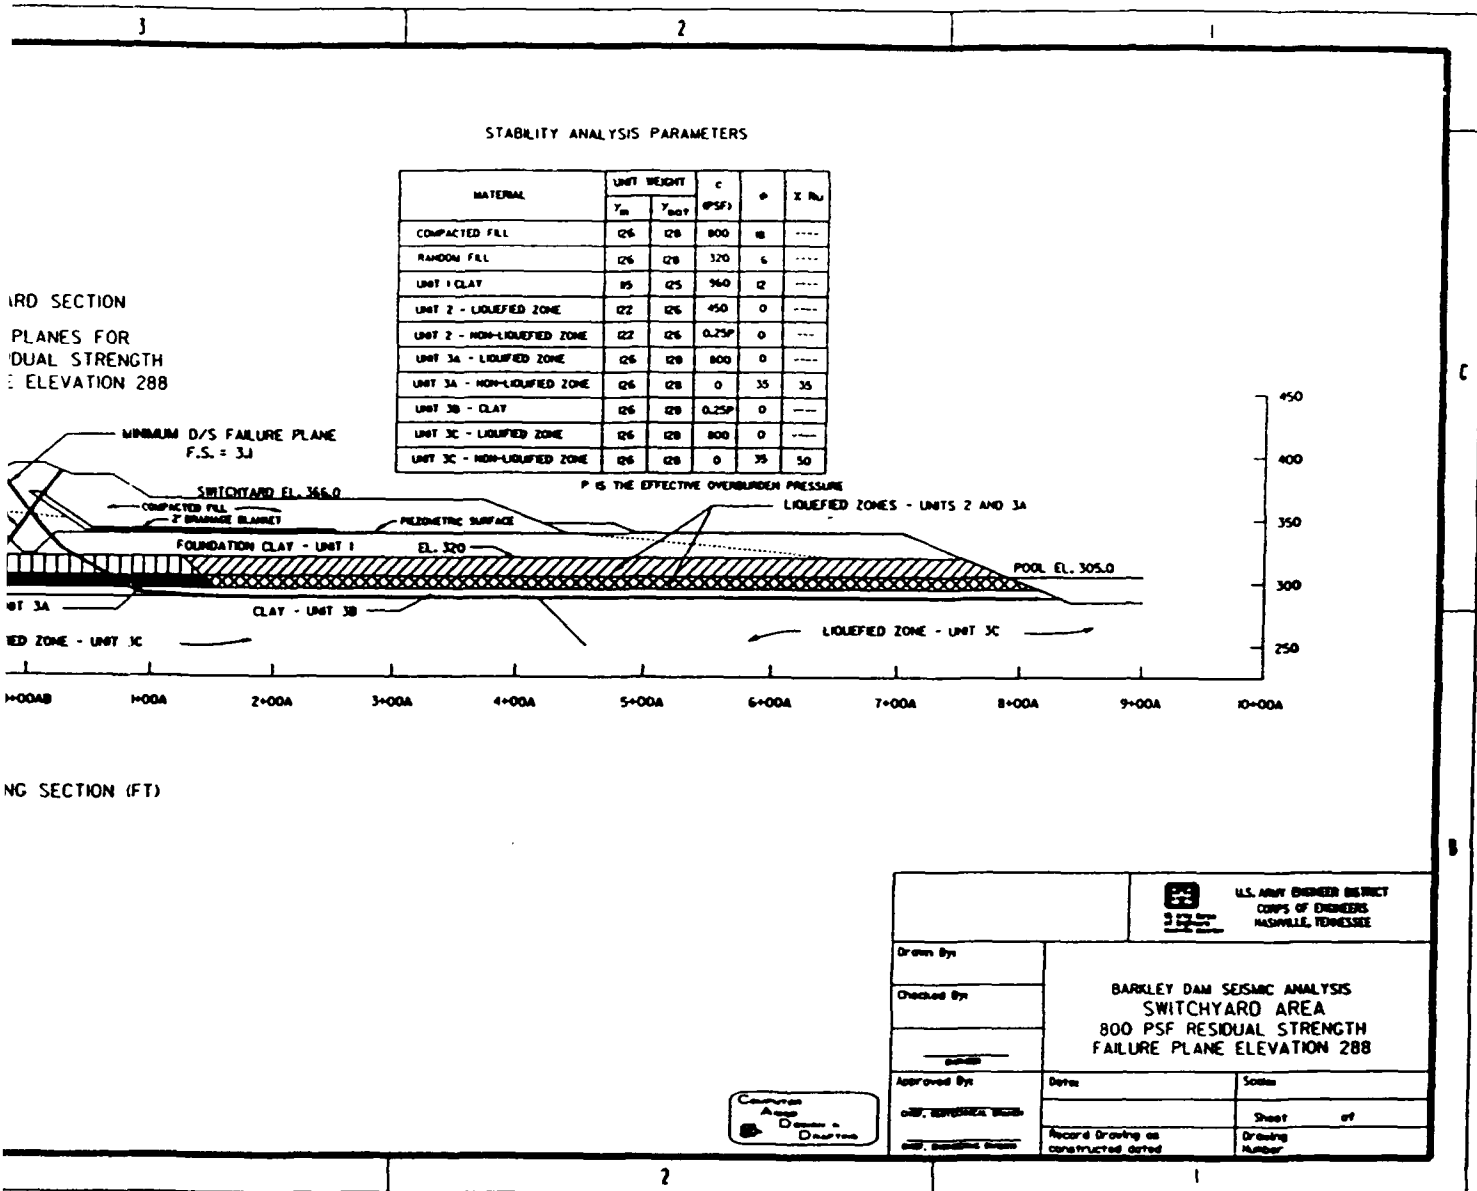
Figure 22. Minimum failure planes
800 psf residual strength in liq

failure planes at elevation 288 feet with strength in liquefied zone of Unit 3C.

45. Using the full residual strength of 1200 psf, the minimum failure surface at elevation 288 feet produced factors of safety of 2.7 and 3.3 for the upstream and downstream slopes, respectively, indicating that large scale movement and deformations are not anticipated. Using zero strengths in the liquefied zones produced factors of safety of 0.5 and 2.5 for the respective failure surfaces. Because of the large non-liquefied zone under the switchyard, it contributed a large portion of the strength along the minimum failure plane and a high factor of safety. On the upstream side, the entire zone at this elevation was considered to have liquefied and with zero strength produced a safety factor less than one. For the minimum upstream failure plane, a residual strength of 200 psf is needed for a stable condition. The pre-earthquake safety factors for the upstream and downstream surfaces are both 5.2. The minimum failure surfaces are shown in Figures 22-23 and Table 3 summarizes the results.

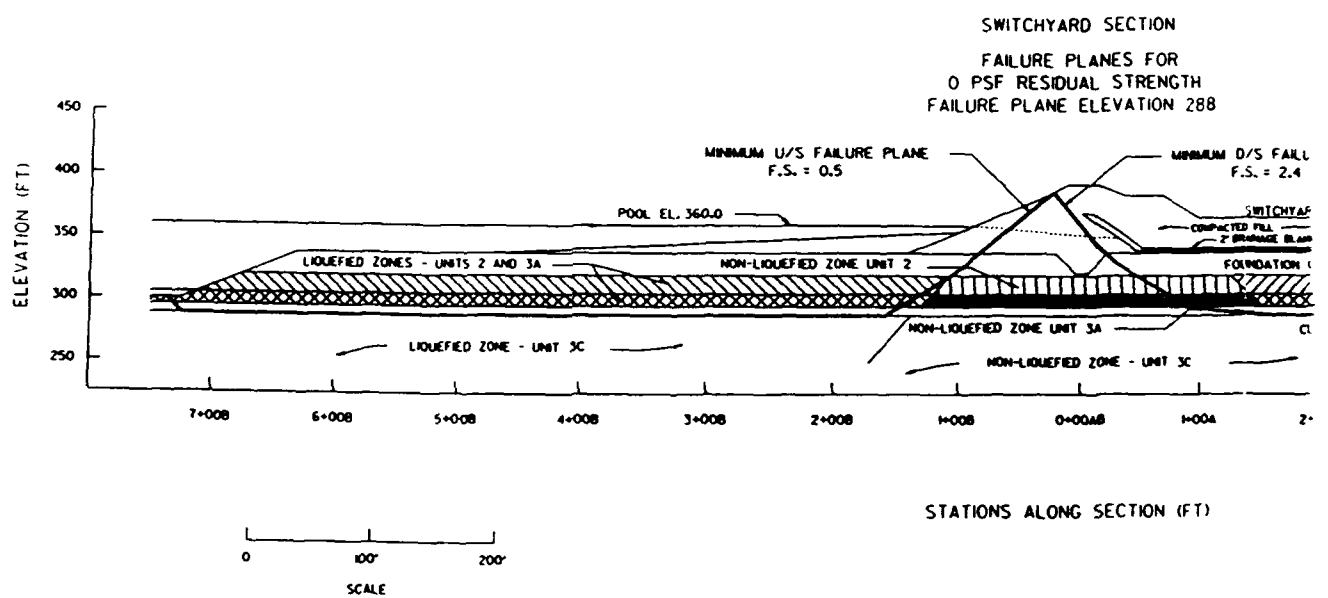
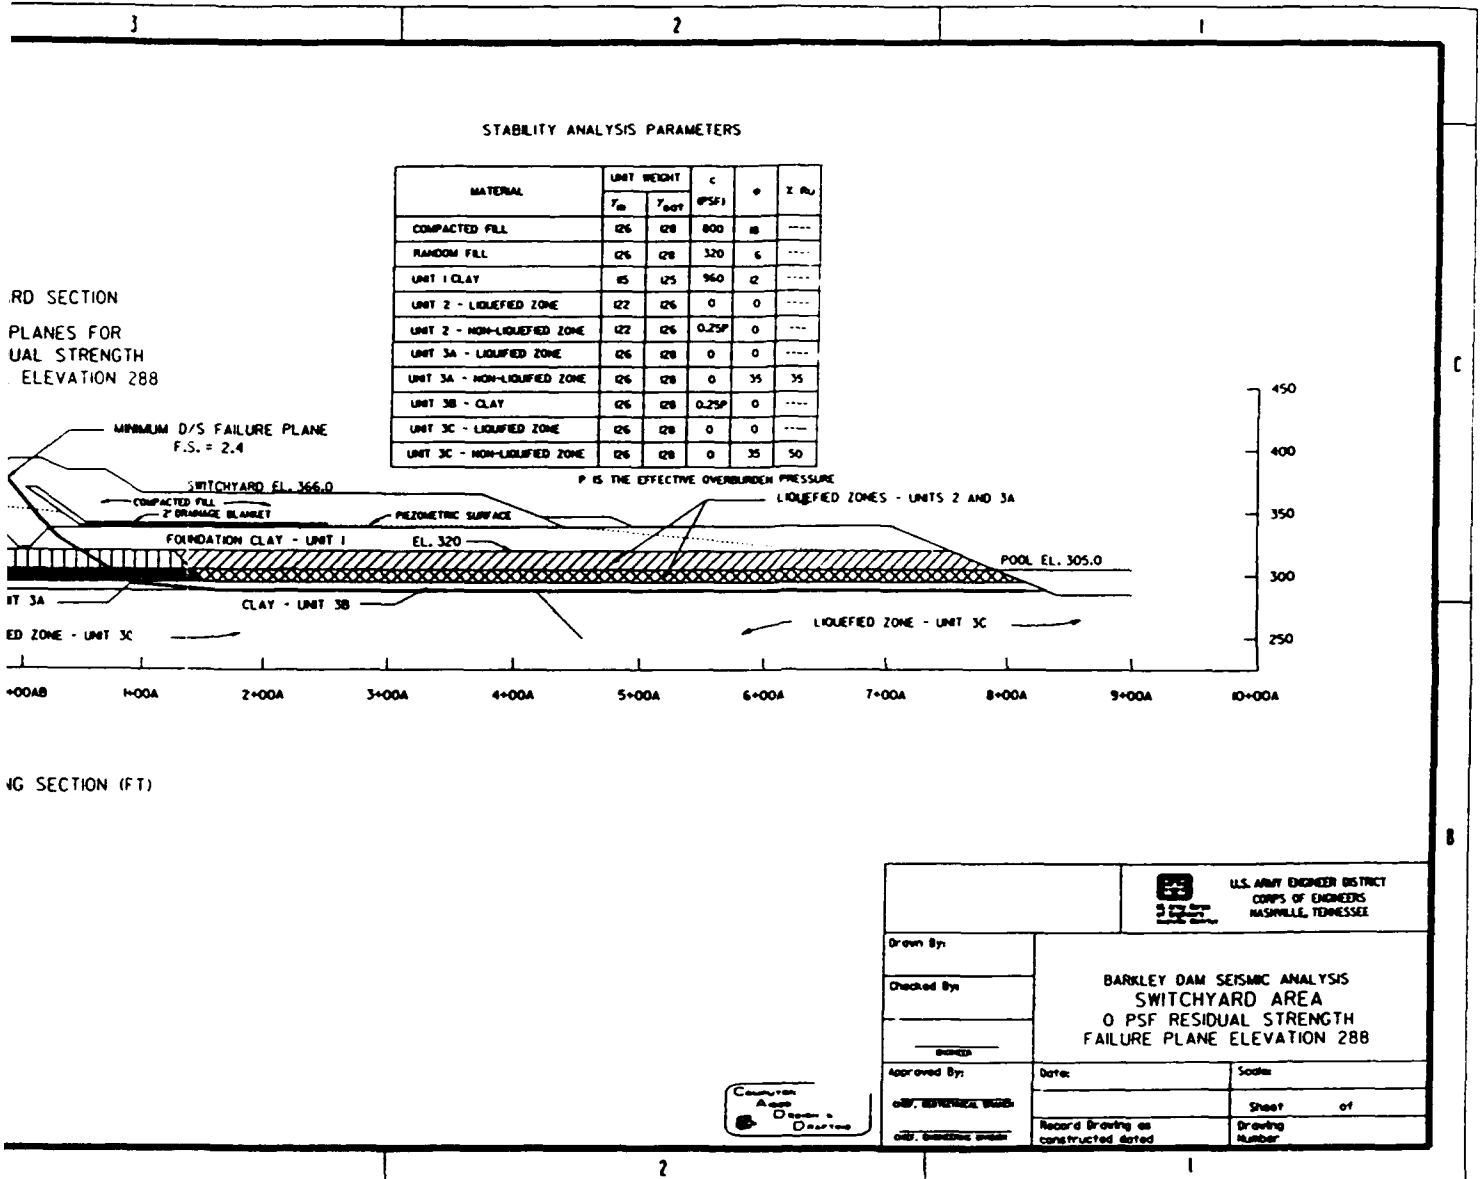
Figure 23. Minimum failure planes at residual strength in liquef

are planes at elevation 288 feet with 0 psf
gth in liquefied zone of Unit 3C.
